PROJECT: WILUNA VOID SCAN

Wiluna Mining Corporation

Wiluna Gold Operation

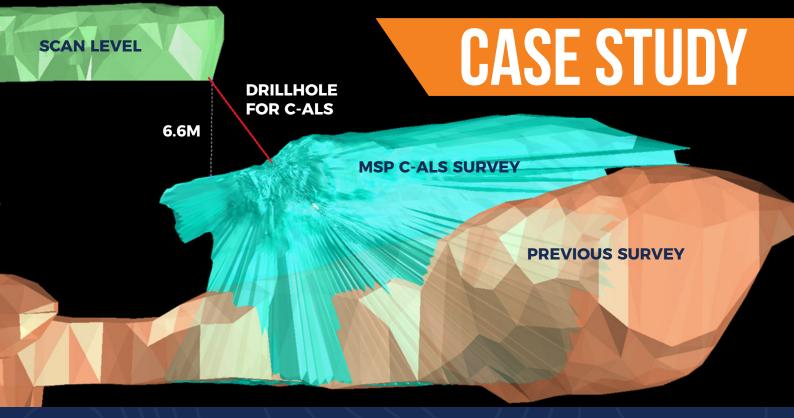
Mine Survey Plus utilised their C-ALS (Cavity Autoscanning Laser System) with internal gyro to perform an in-stope scan through a 90mm probe hole. From start to finish, the job was completed in under 45 minutes with a scanning time of 15 minutes.

The survey was completed safely and with minimal disruption to mining. The resulting data showed the void being larger and closer than recorded on existing mine plans and provided a higher degree of confidence in planning future development.
